Reliability Coordination of Power Stations Connected Radially to Grid through EHV Pooling Stations

Chandan Kumar, Selvamani Prabhakaran, Vivek Pandey, Pushpa Seshadri
WRLDC, POSOCO
India

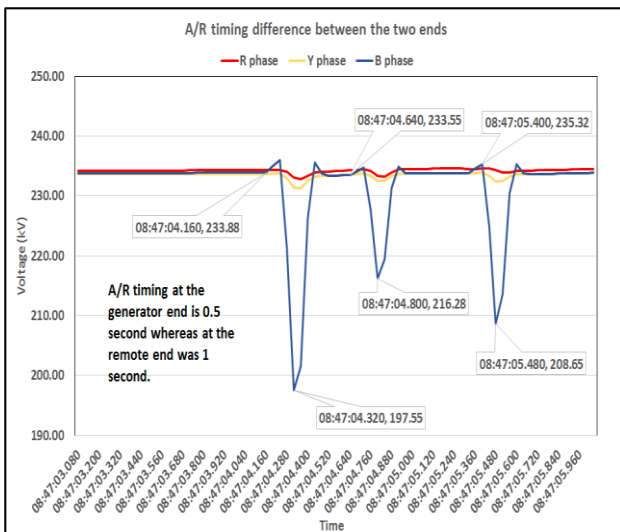
Figure 3: Different auto-reclosure timing

Figure 3 illustrates the case of un-coordinated auto reclosing dead time at the two ends. At the generating station (Plant 6) end the dead time for auto-reclosure on the evacuation line was 0.5 seconds while at the pooling station it was set as 1 second [12]. This led to

the feeding of the same fault from the system two times while auto-reclosure was performed from each end due to different time setting.

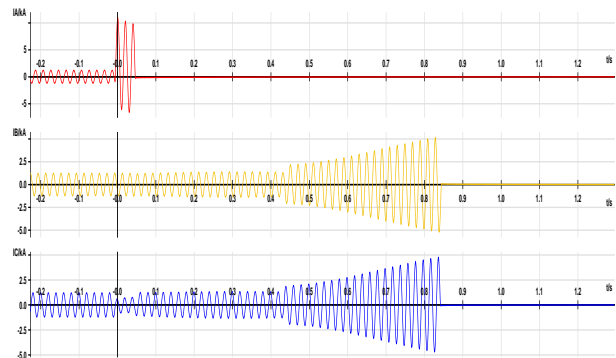
During the blackouts mentioned in Sl. no I, X, XIII, XIX and XXIV given in table 1, power swing/load encroachment was observed in power plant 1 and 2. During the single-phase auto-reclosing on one of the evacuation lines, the power flow on the other line increased and caused relays to pick up in zone 2/zone 3 [Fig 4] as the resistive reach setting was not properly calculated and coordinated.

Figure 4: Power swing in the healthy phases during auto-reclosure causing tripping of lines in load encroachment.

To resolve the above issue, power plants were advised to calculate resistive reach and check load encroachment in Zone 1/2/3 for the worst case scenario i.e. N-1 of one circuit and with only two phase of the other circuit. This setting was adopted in three of the generating plants which were connected to the grid through long lines. Since then no such issues have been reported. The same information was shared with other radially connected power plants to avoid spurious tripping in future.

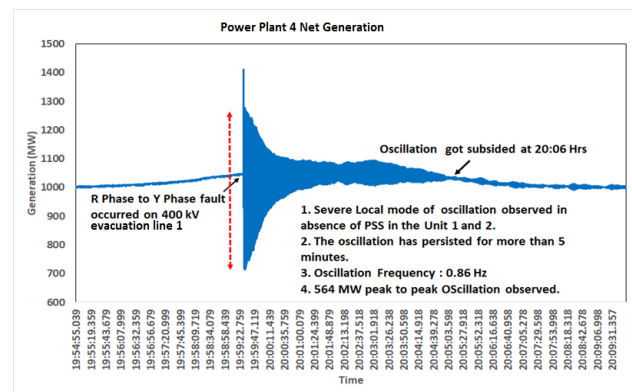
Low frequency oscillations have been a triggered in the Indian grid under various contingencies or operating conditions [13]. In one of the cases, high amplitude-poorly damped oscillations of 0.86 Hz [Ref Fig 5] were observed at a power plant (power plant 4) when one of the evacuating lines tripped [14]. The oscillations persisted for 5 minutes and were observed at nearby generating stations also. Post facto analysis revealed that the Power System Stabilizer was out of service at the station.

Figure 5: Low frequency Oscillation in Power plant 4 during a contingency (No PSS).

1. **Angular Separation under N-1 Contingency under different loading:** System study was performed for all the radial generators for finding the angular separation between the generator and its pooling station under N-1 contingency. This provided the idea of vulnerable stations.
2. **Transient study for Generators with High Angular Separation:** Transient studies were performed for Generators having more than 15-degree angular separation (as found in step 1).
3. **Power System Stabilizer (PSS) Tuning:** PSS tuning was completed for all these generating stations with high angular separation.
4. **System protection scheme (SPS) Implementation:** SPS for implementing runback under an N-1 contingency was designed and got implemented. SPS operation was coordinated to reduce the amplitude of power swing and allow single phase auto-reclosing.

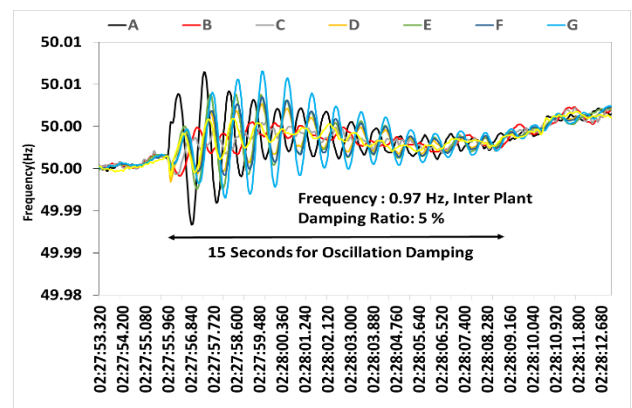
In another case, one of the outgoing lines from a station (Plant 1) had a single phase to earth fault. Single phase auto reclosure operated. However, a large power swing was observed at a power station (Plant 1) during the auto reclosing dead-time and caused a three phase trip of both the evacuating lines [5]. In five cases, high amplitude, poorly damped low frequency oscillations were observed at power plant 1, under an N-1 contingency. Oscillation plot for one of the cases is shown in figure 6.

Figure 6: Plot of oscillation observed in frequencies near to power plants 1 during an N-1 contingency.

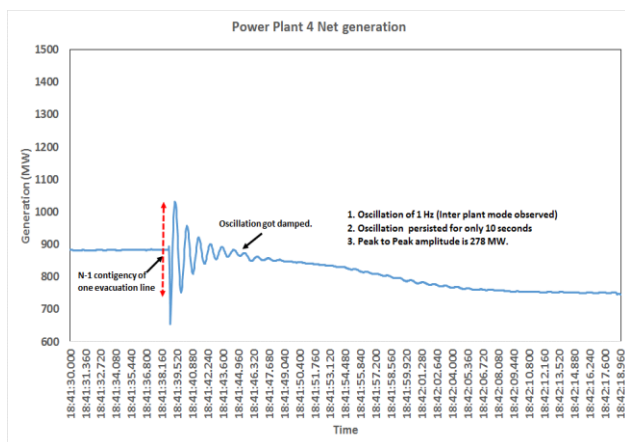
The above steps were implemented in three generating plants. The impact of these measures in Plant 4 may be seen by comparing Fig 5 with Fig 7. Similarly, Fig 6 may be compared with Fig 8 to assess the impact of the corrective measures implemented in Plant 1. No blackout has been reported at these Power plants since then [13]. Figure 7 illustrates reduced amplitude of oscillations and improved damping at power plant 4. For similar contingency at plant 1, the oscillation which persisted for more than 5 minutes (Fig 6) earlier got damped within 10 seconds (Fig 8) after tuning of PSS 1. The oscillation frequency also changed from intra-area mode to inter-plant mode.

Figure 7: Improvement in damping of LFO in Power plant 4 with tuned PSS and SPS implementation.

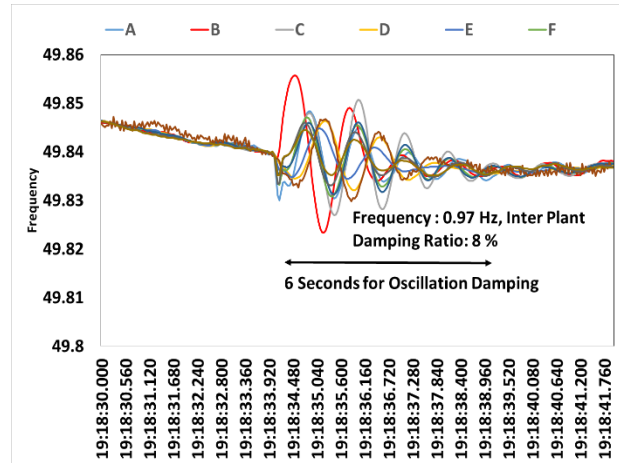
Figure 8: Plot of oscillation observed in frequencies near to power plants 1 during N-1 contingency after implementation of the remedial steps.

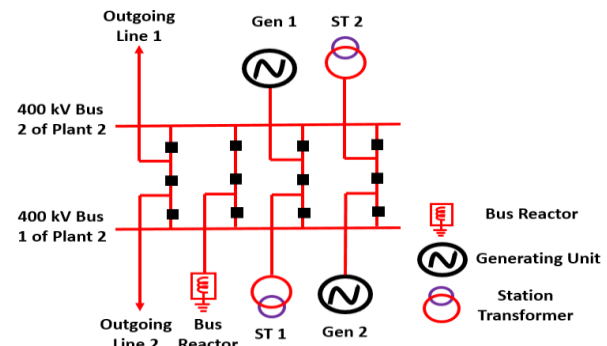
Most of such generating stations have one and a half breaker bus bar scheme and few have double main transfer scheme. There was a case of the blackout in one of the power plants (Plant 2, with a one-and-half breaker scheme given in Fig 9) in the Western region when both buses tripped. It can be observed that both evacuation lines were in the same diameter so with the outage of both buses, units got isolated from the grid. Thus the substation layout plays an important role in station reliability under various contingencies.

Figure 9: Power Plant 2 substation layout causing a blackout in case of tripping of both buses.

So, in case of one and a half breaker scheme, it is desirable that the outgoing line should be in the same diameter as the generating unit [Ref figure 10]. This will help in keeping the units in service with evacuation lines even if both the buses are dead. In this configuration, it is advisable to keep the major loads of the power plant in order to survive under the stressed condition on the unit auxiliary transformer (UAT) rather than station transformer.
